AIRCRAFT ACCIDENT INVESTIGATION FINAL REPORT

REPORT ON AN ACCIDENT INVESTIGATION INVOLVING A GIPPSLAND
AEROSPACE (NOW MAHINDRA) GA – 8 AIRVAN REGISTERED A2 – MBE
THAT OCCURRED AT OAKDENE AIRFIELD ON THE 29TH JUNE 2023.

REFERENCE: MTPW/AIG/14/23

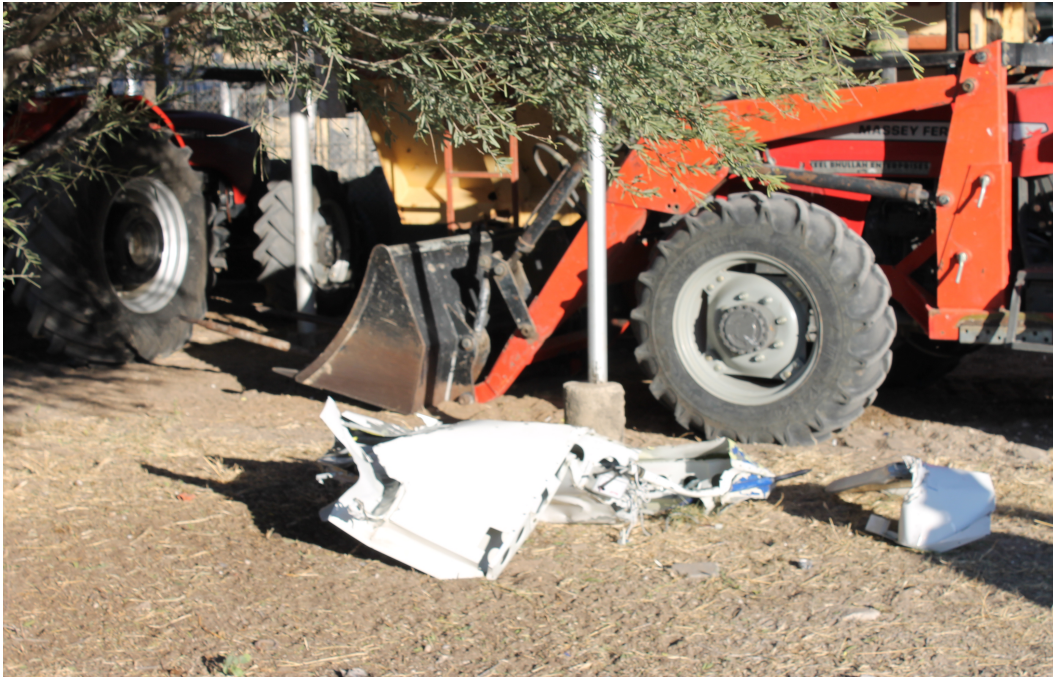
Figure 1: Images of the chopped off port wing tip that remained at the initial spot of collision.

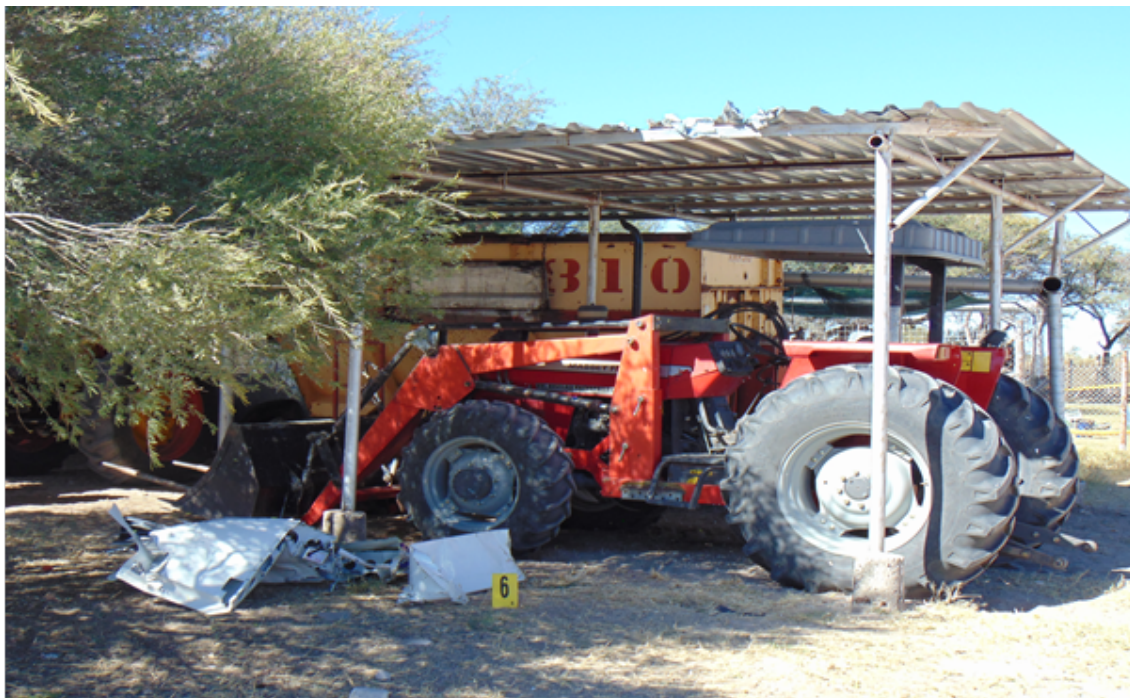
Figure 1b: View of the tree branch and the vehicle shade roof reflecting the impact from collision with port wing. (Initial points of collision).

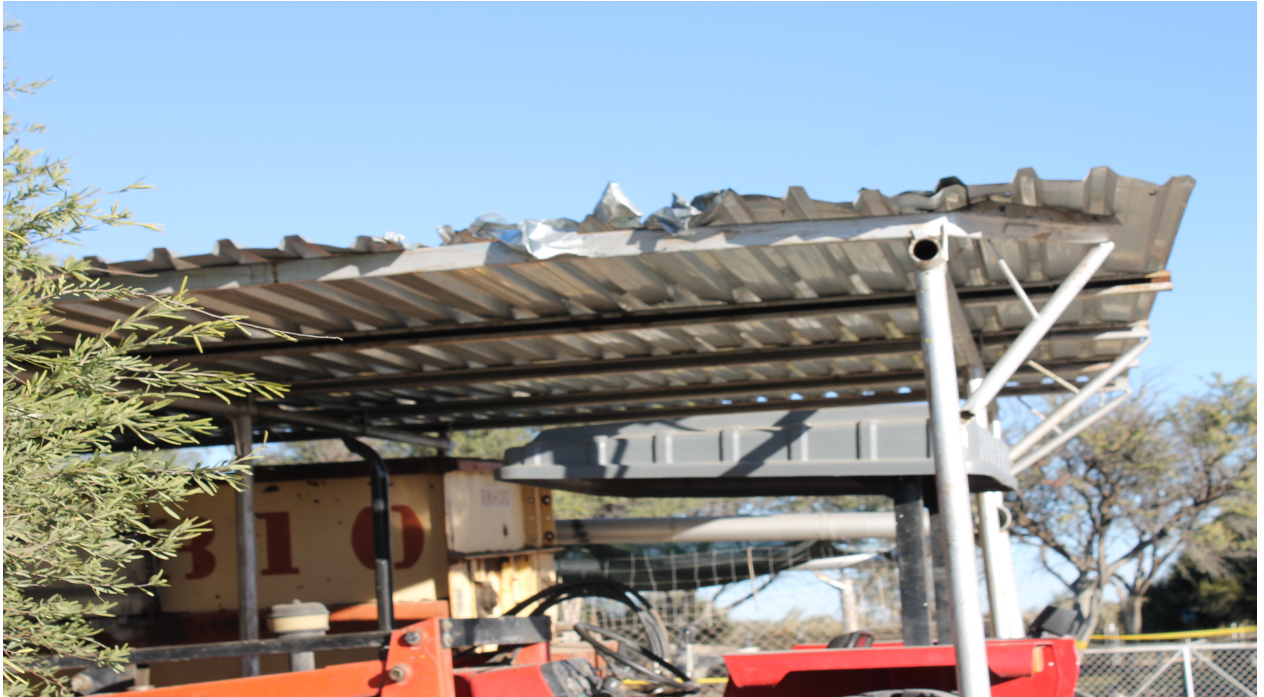
Figure 1c: Close view of the resulting damage on the vehicle shade roof structure

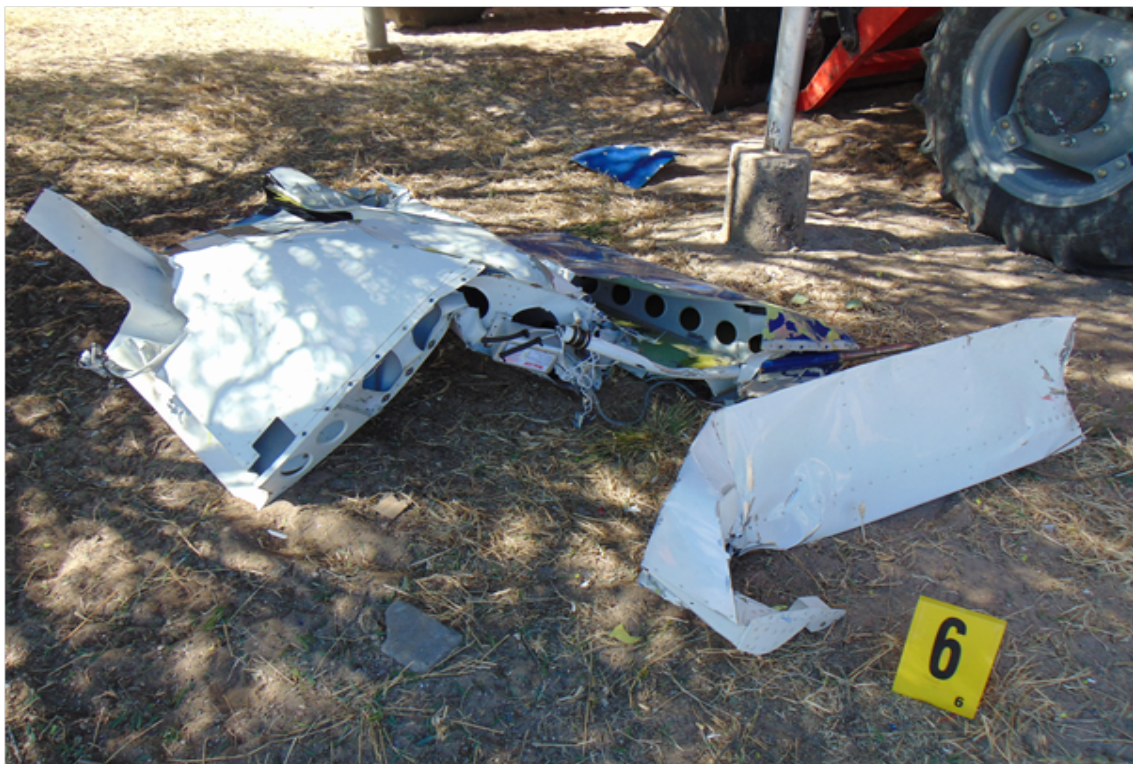
Figure 1d: Close view of the port wing tip that fell off at the spot of initial collision.

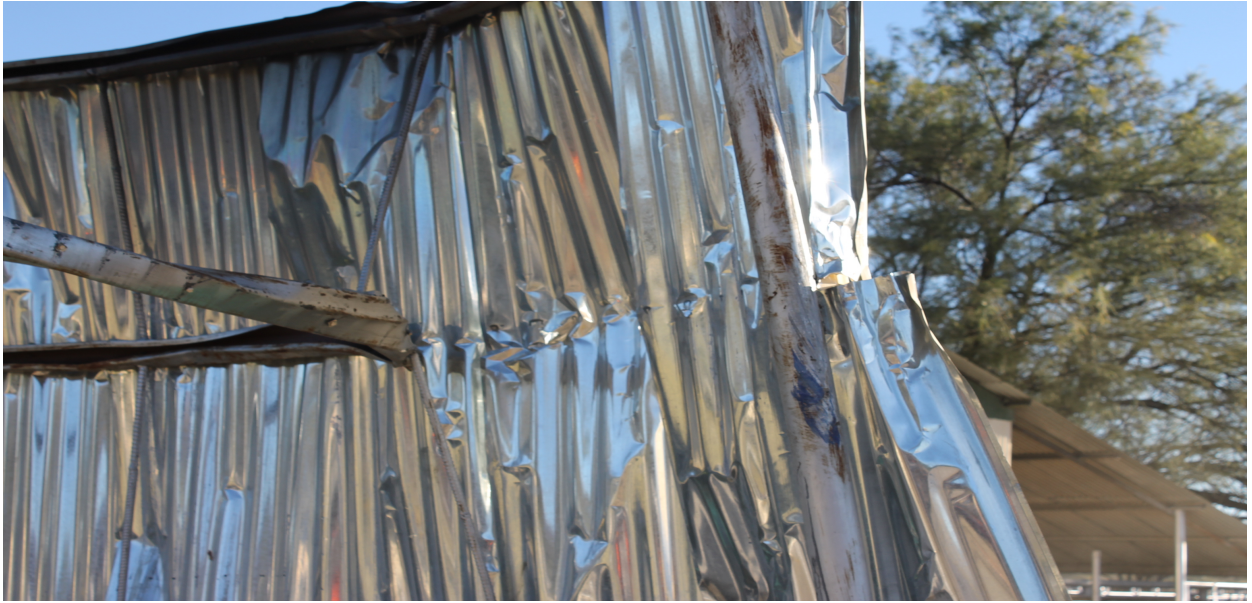
Figure 2: View of the next collision impact point after the vehicle shade which is a milling equipment roof next to the farm shed.

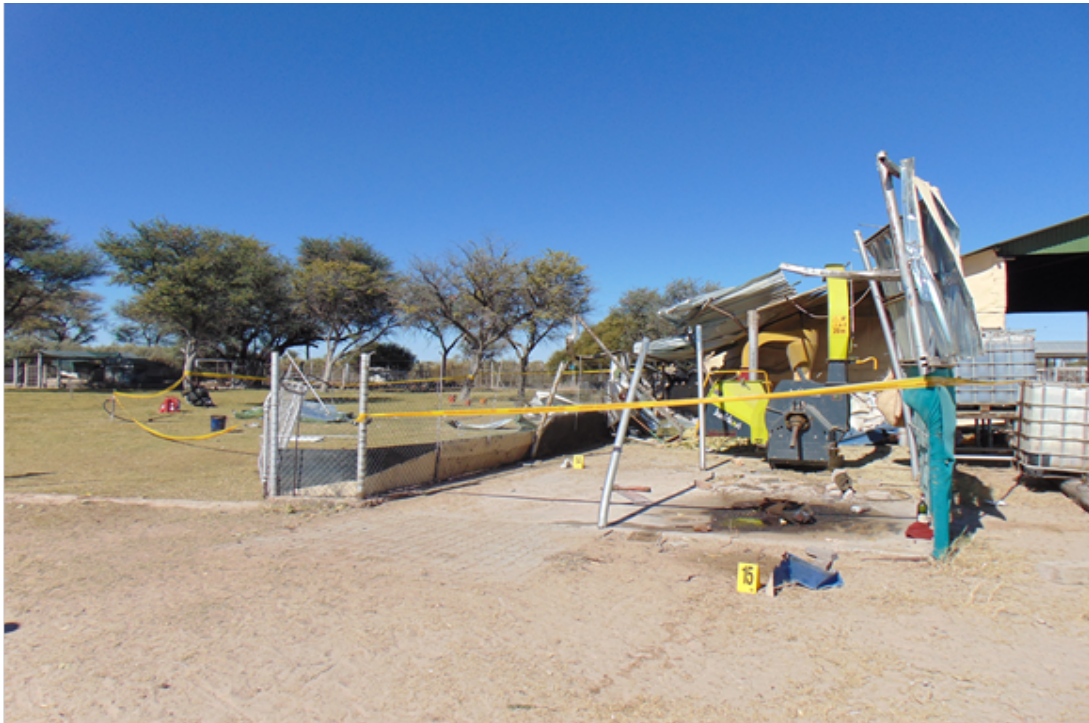
Figure 2b: Front view of the decimated roof of the milling shed next to the main farm shed.

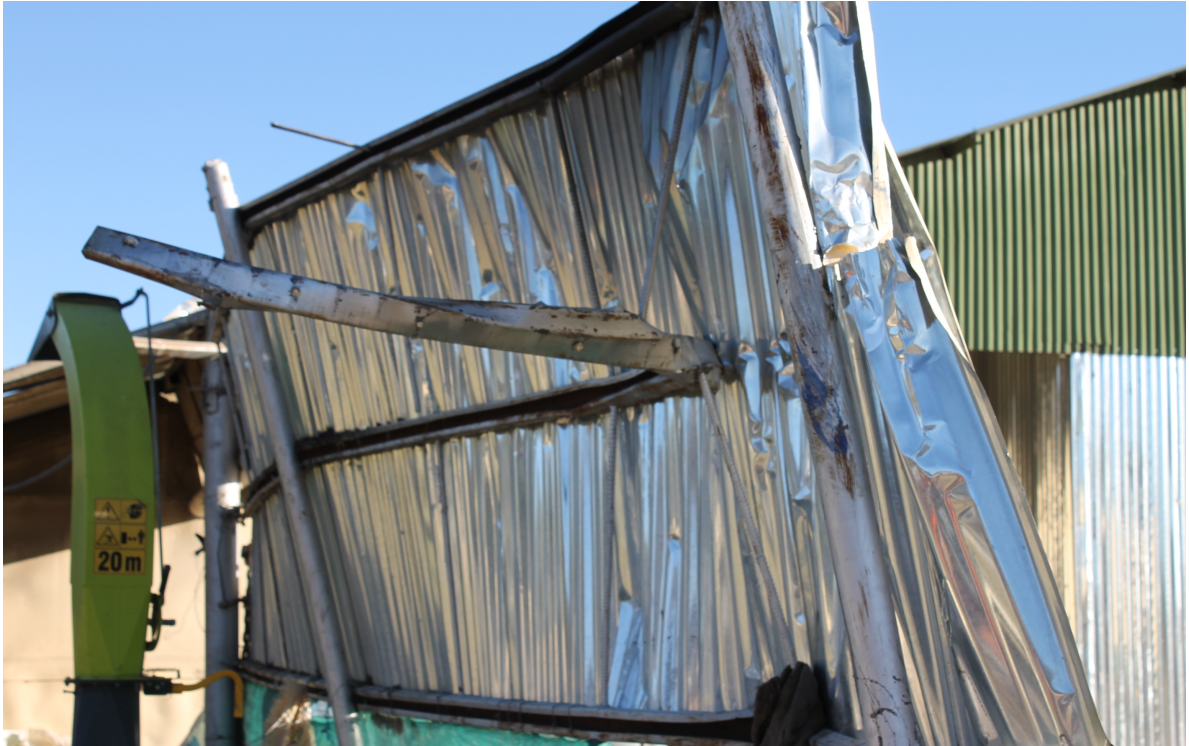
Figure 2c: View of the roof beam structure that probably caused the aircraft to flip over.

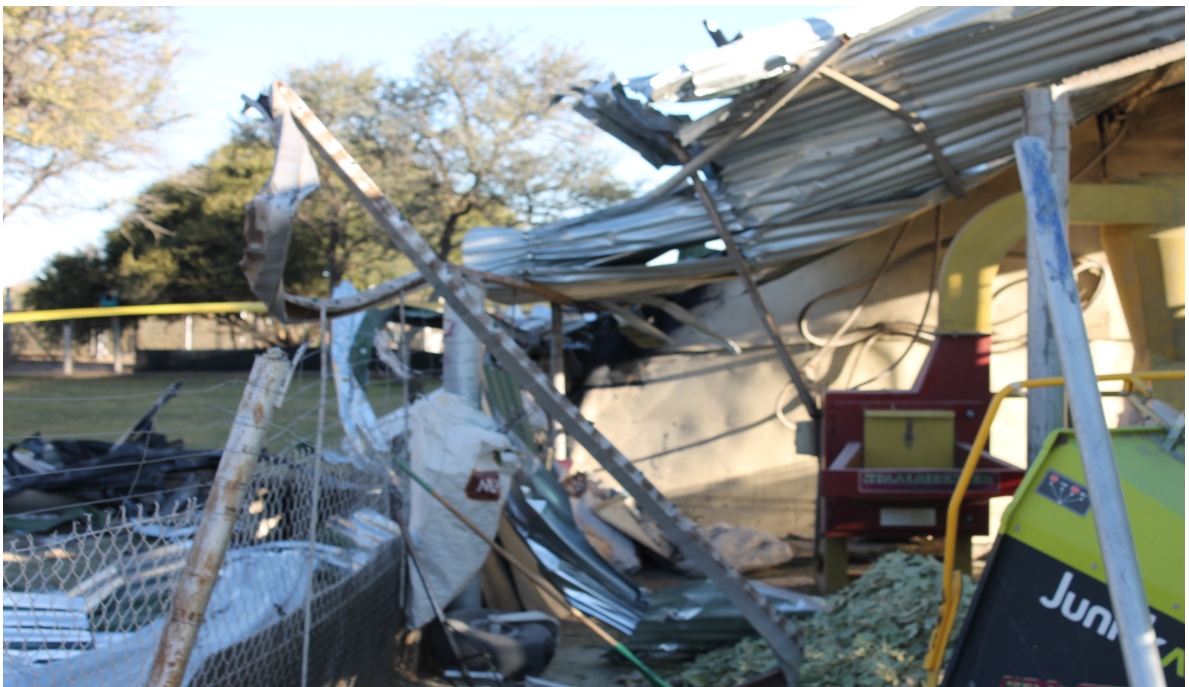
Figure 2d: The decimated roof truss of the milling equipment structure.

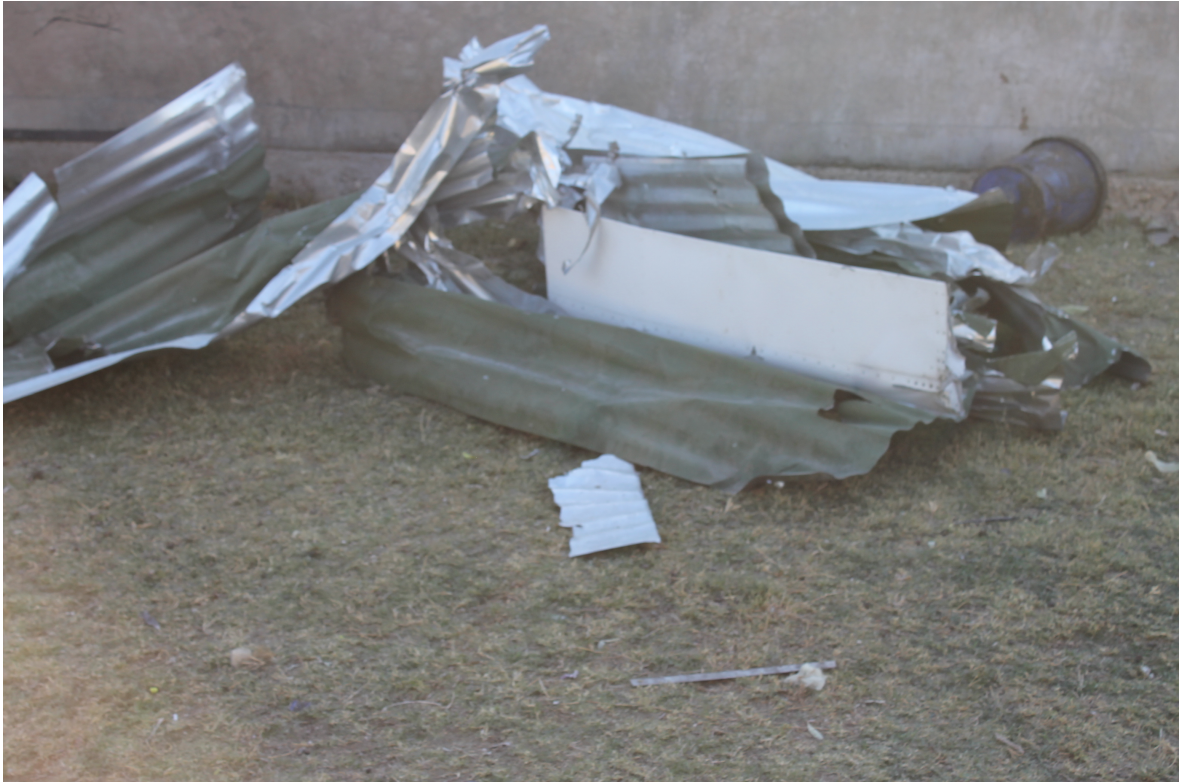
Figure 2e: Sheet metal following the collision left strewn by the farm shed.

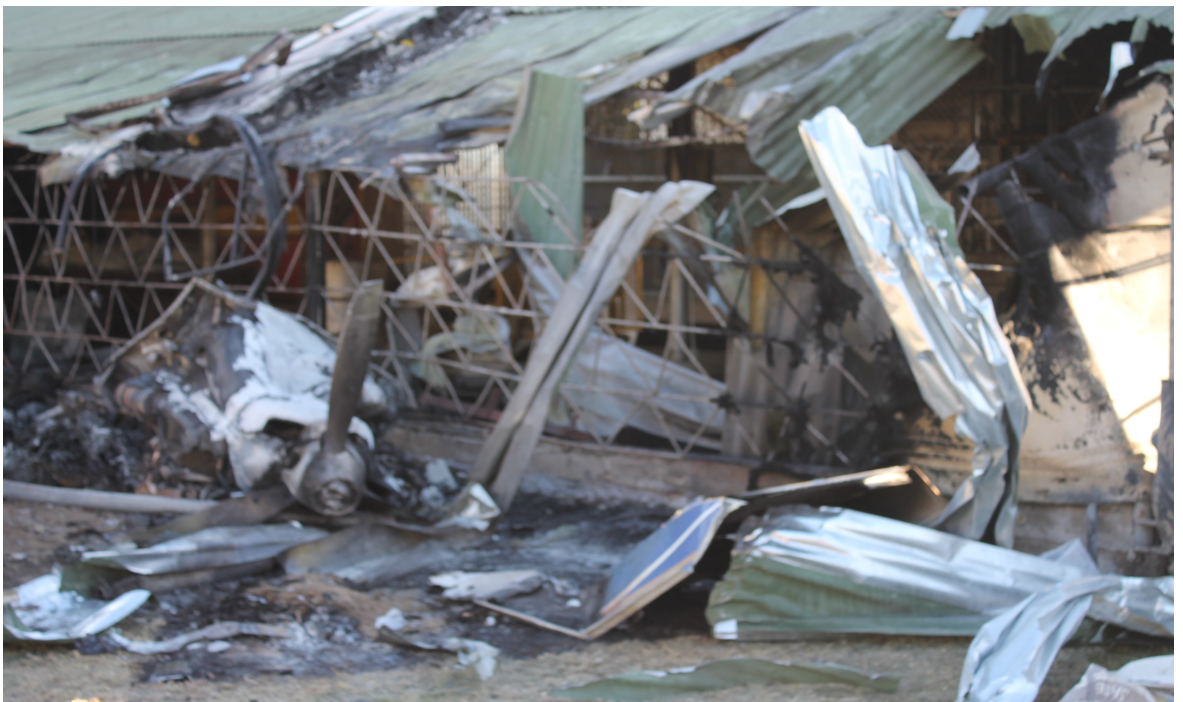
Figure 2f: View of aircraft nose with propeller blades next to damaged side wall of the farm shed.

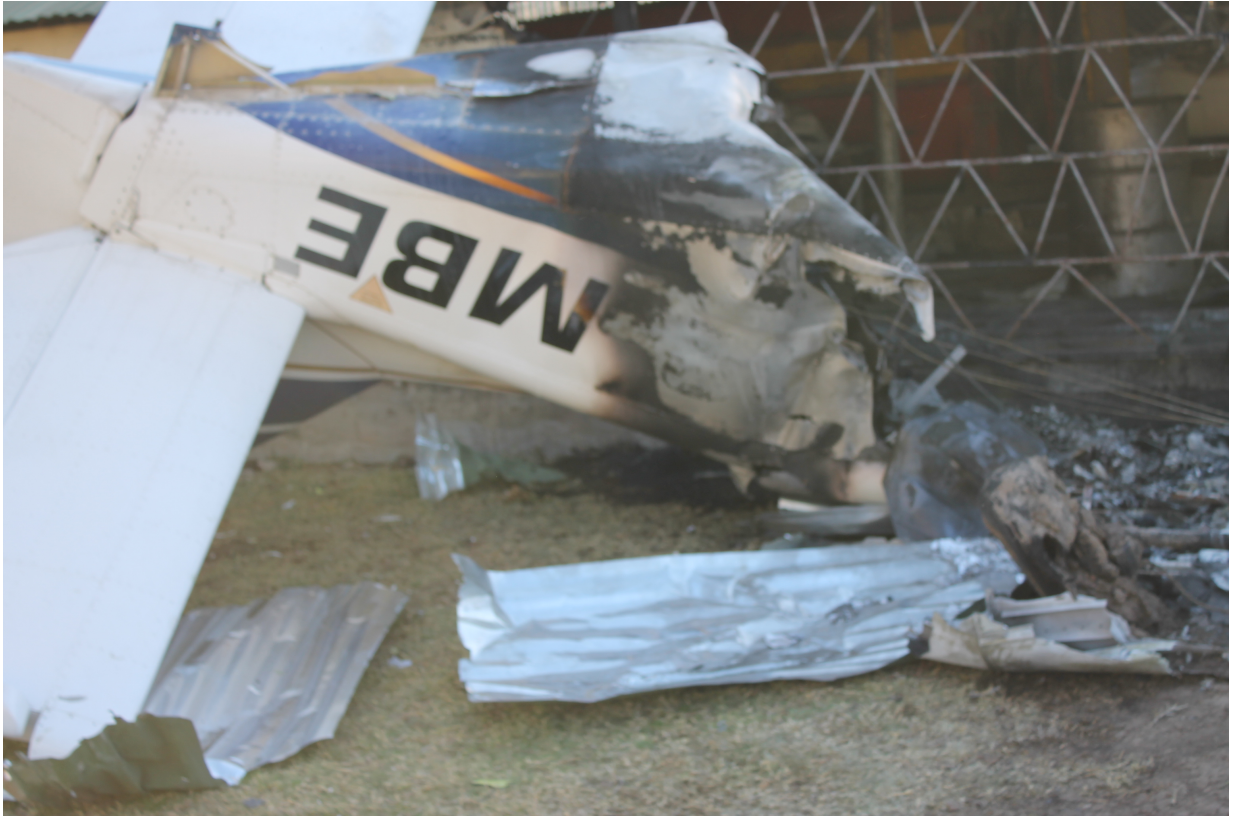
Figure 2g: View of a remaining aircraft empennage next to the farm shed.

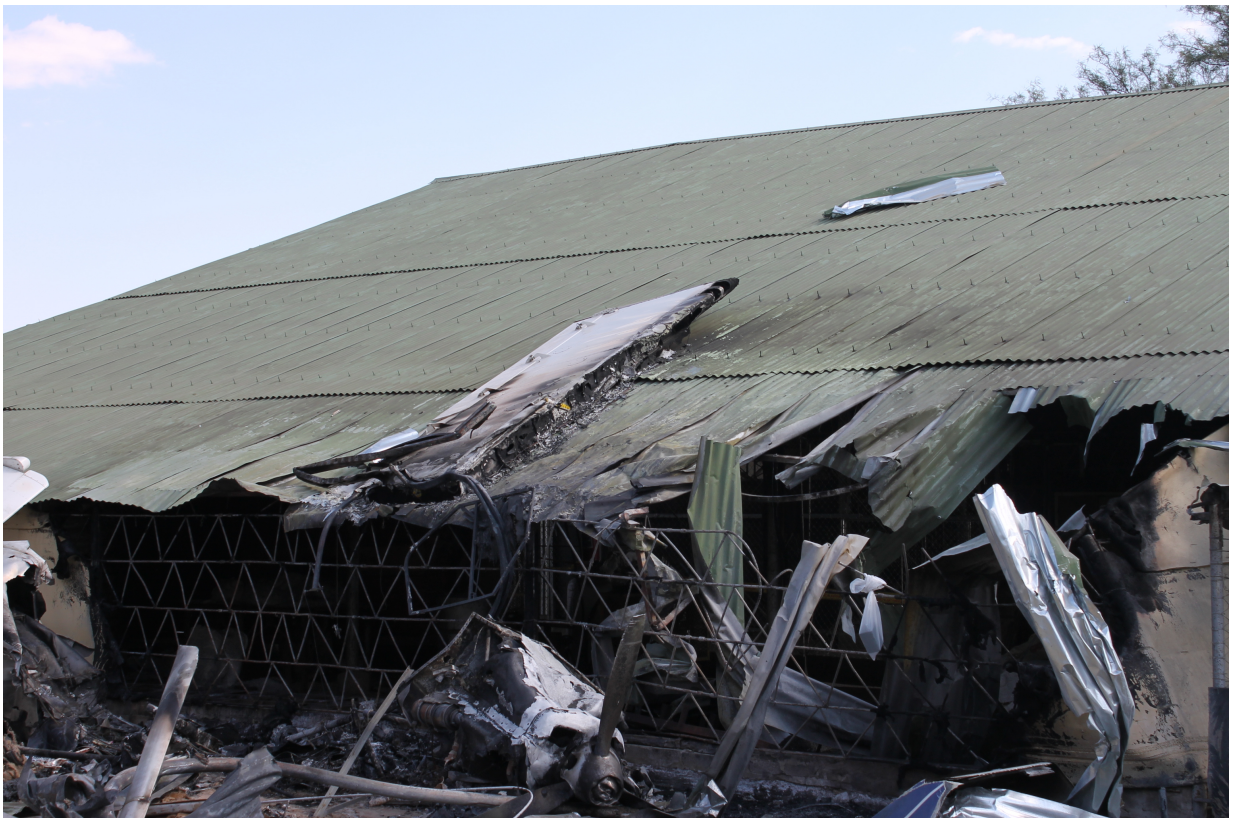
The right-wing broke off at the root of the fuselage and ended up resting on top of the farm shed. The remaining aircraft wreckage fell onto the ground by the farm shed. Fuel gushed out of the right-wing tanks and fuelled the post impact fire that engulfed the aircraft.

Figure 2h: The torn starboard wing resting on the farm shed roof.

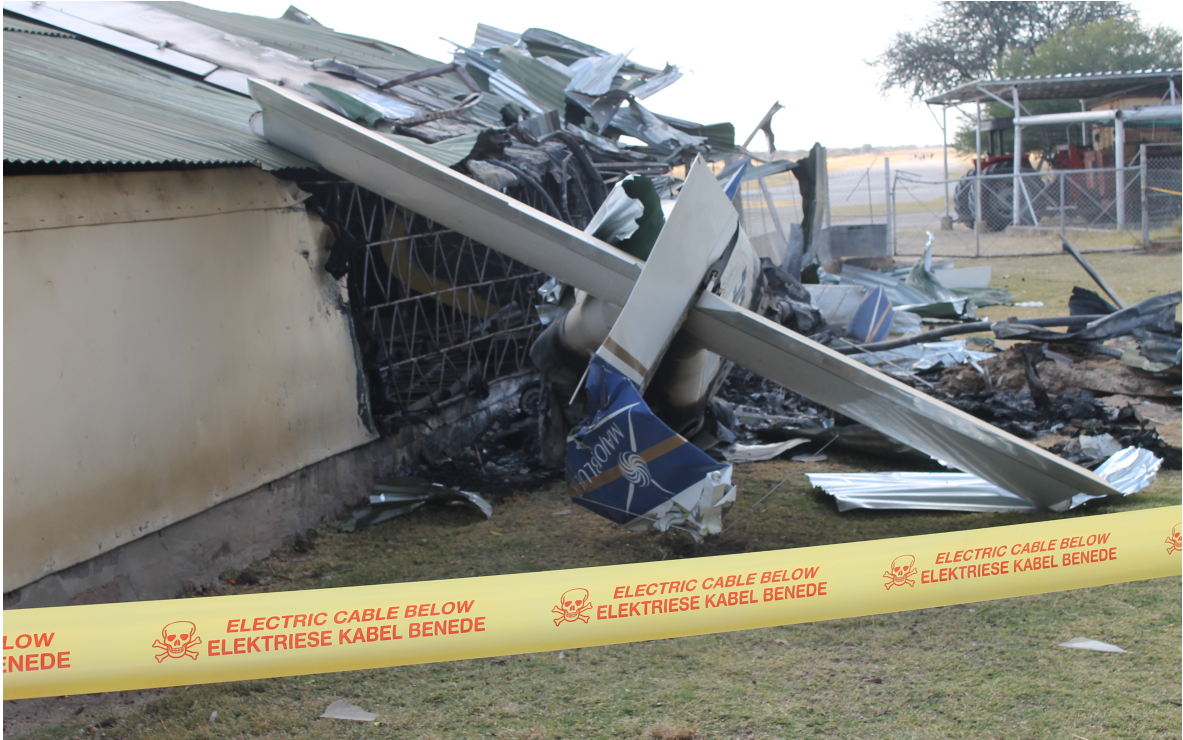
Figure 2i: View of the wreckage facing the runway.

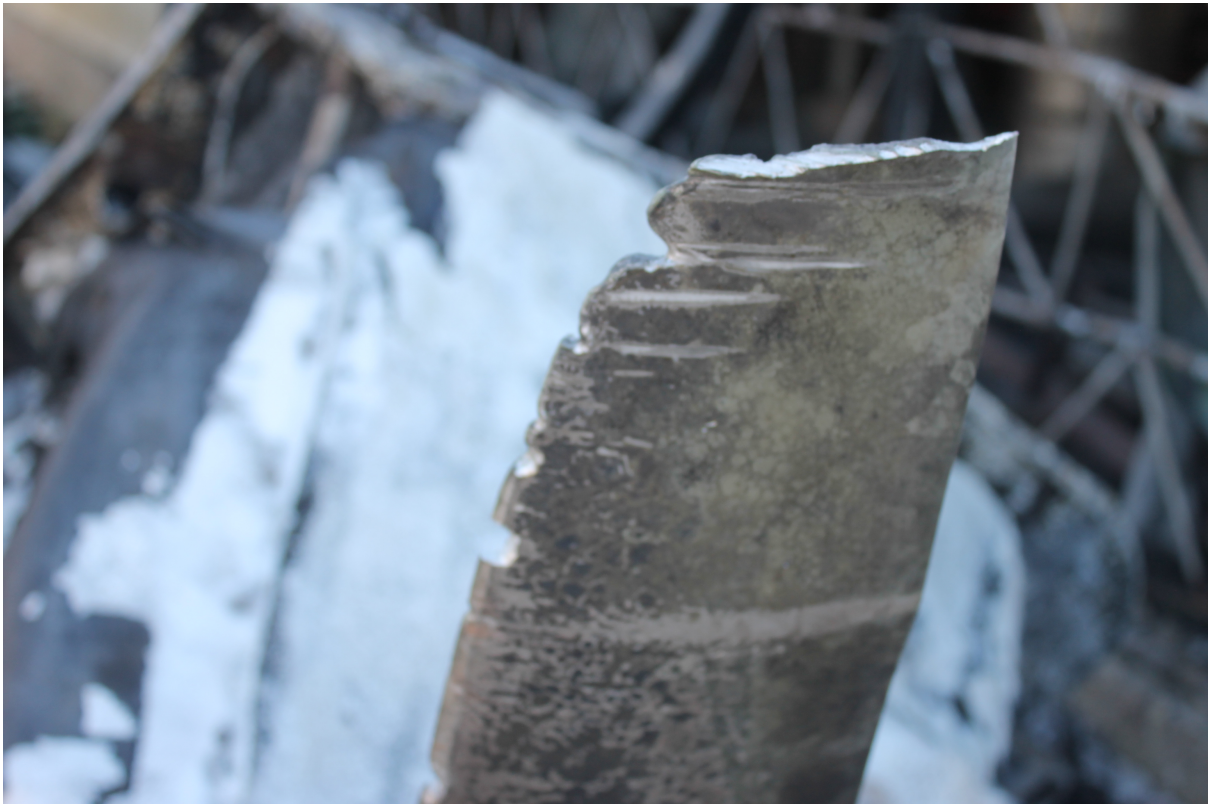
Figure 3: One of the 3 propeller blades with the tip cut off due to collision at maximum speed.

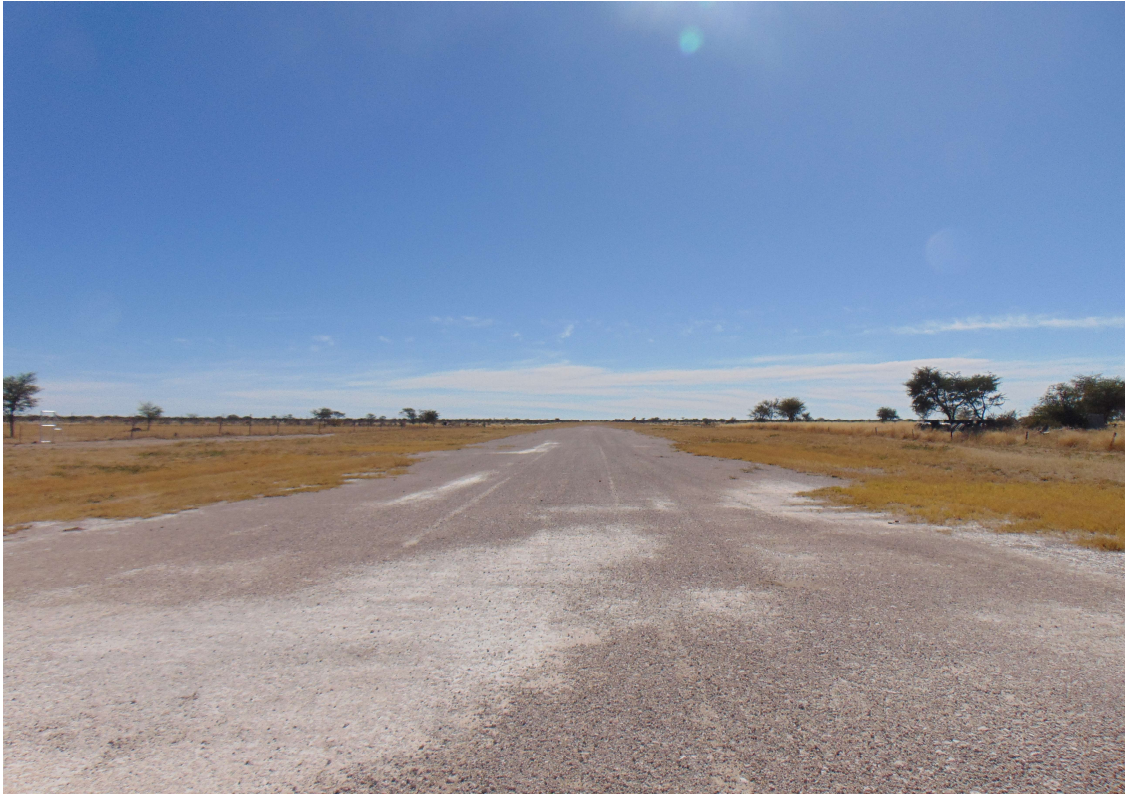
Figure 4: View of the runway (RWY 30) from the direction that A2 – MBE was heading. (looking at the ground run starting point)

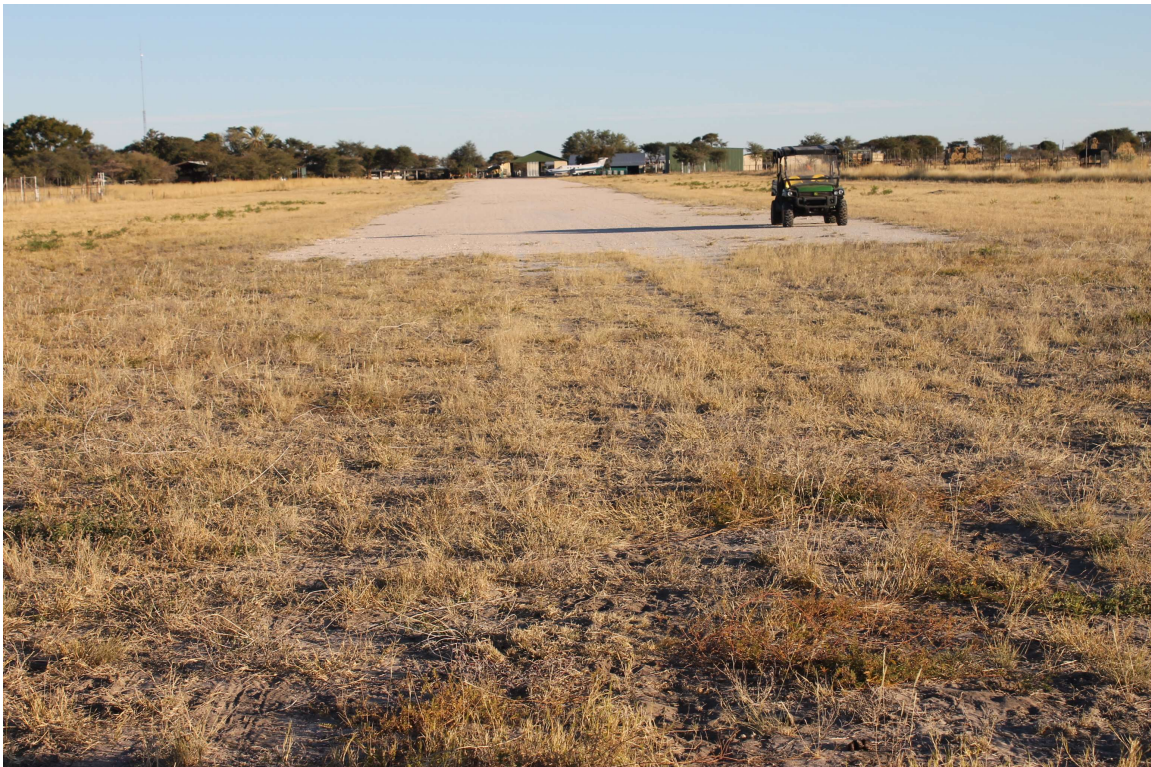
Figure 4b: View from the starting point of the aircraft ground run.

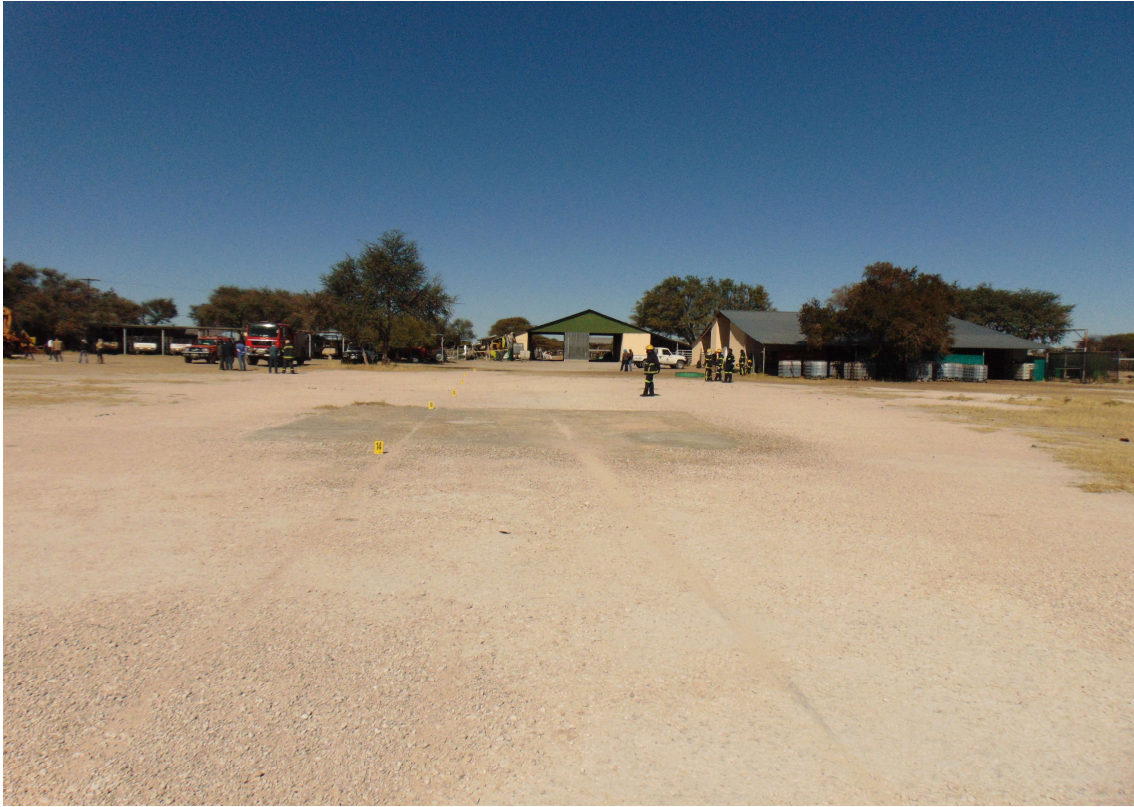
Figure 5: View of the A2 – MBE tracks as it was approaching the engine run-up area prior to encroaching onto runway end safety area.

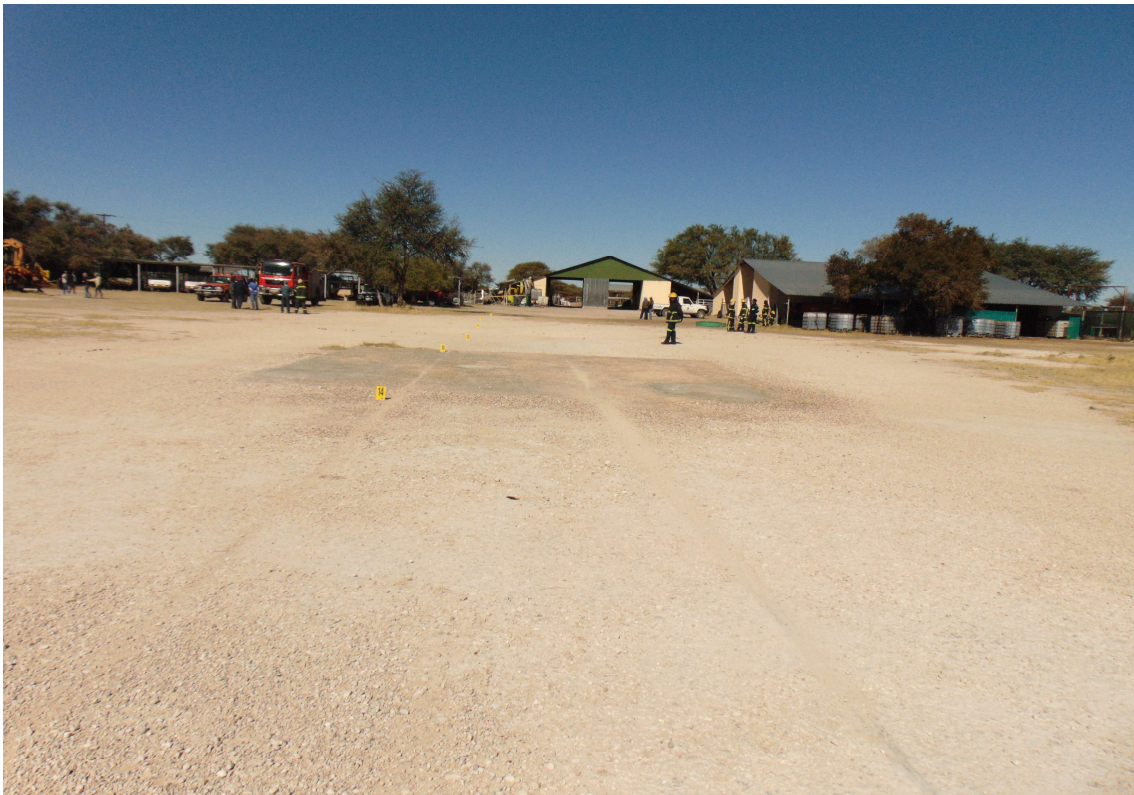
- 2.2 The observed main gear tracks on the compacted ground leading to the concrete surface (engine run-up area) are attributable to applied main landing gear brakes. During the take-off ground run, the main undercarriage was subjected to brake application at this critical phase towards the end of the runway.

Figure 5b: Evidence of main landing gear under brakes at a critical stage

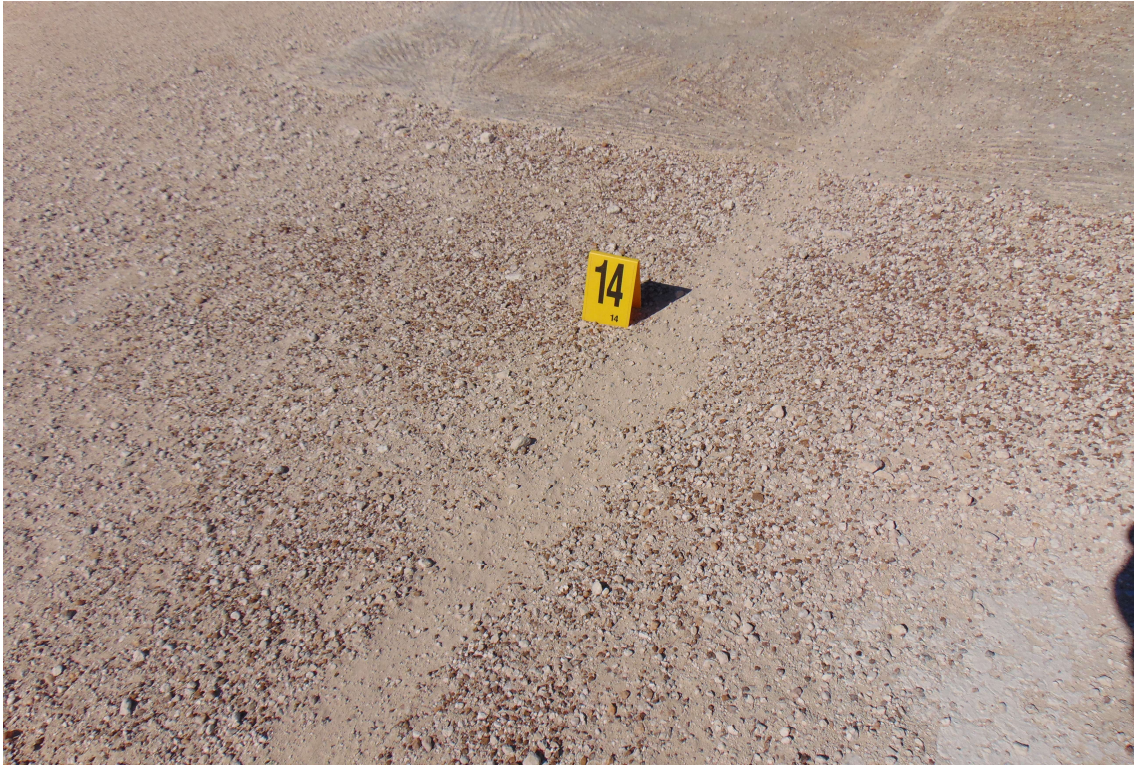
1.16.10 The skid marks (braking tracks) similar to one made by a landing gear under brakes were observed on a concrete surface used as engine run-up area along the path that A2 – MBE took. **(Figures 5c, d,6)**

Figure 5c: Tracks of left main gear approaching the engine run-up area.

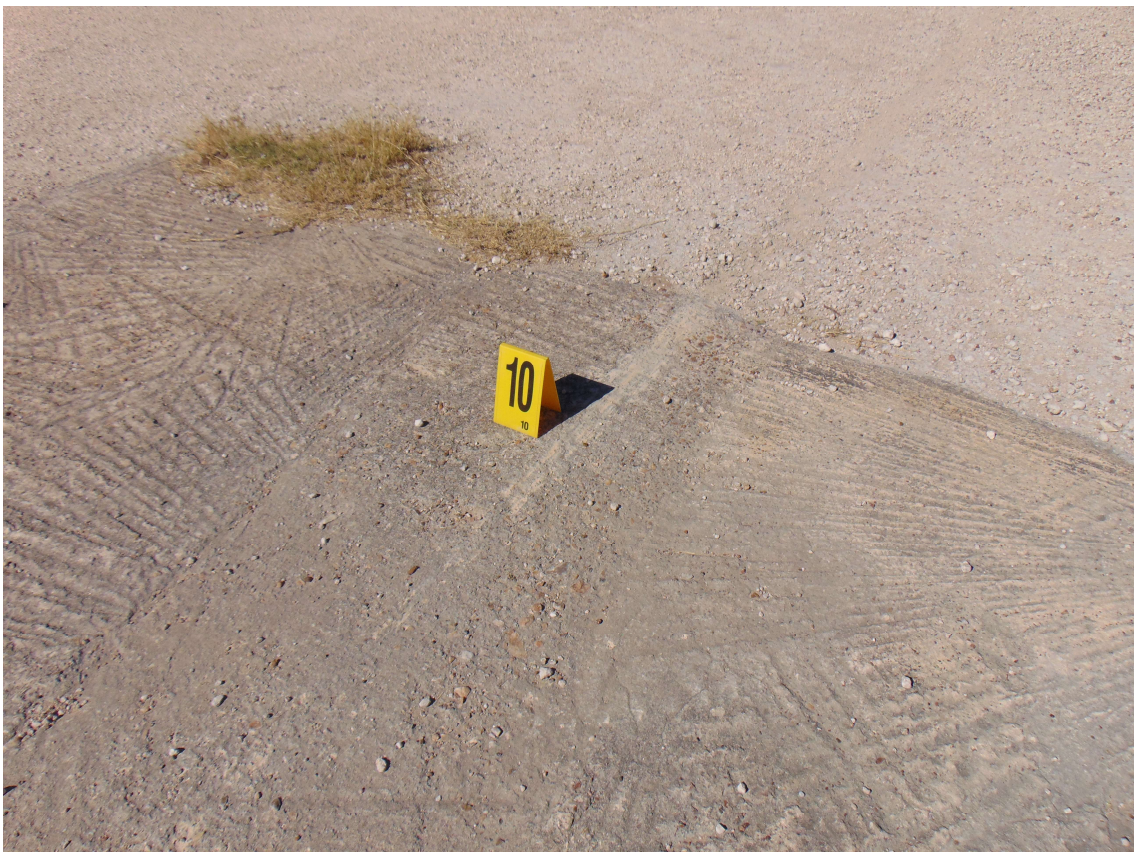
Figure 5d: Track of port side (left) main gear existing the engine run-up area.

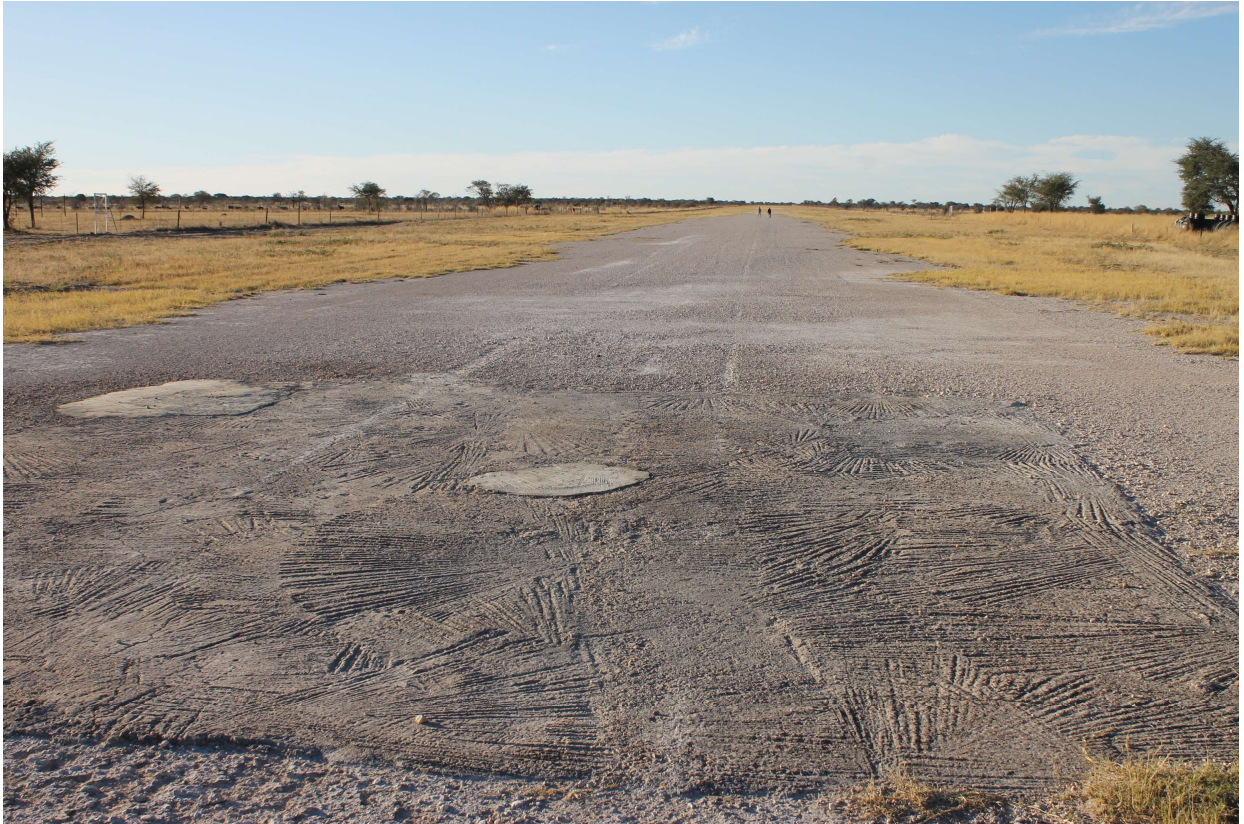
- 3.1.7 There were distinct skid marks measuring a length of approximately 85 meters which resembled main gear under applied brakes. The marks were observed on both the compacted as well as the concrete surface path that A2 – MBE took. *This part of the area is towards the runway end.* The observed tracks were consistent with the applied brakes on subject aircraft main landing gear.

Figure 6: view of the main gear tracks over the engine run-up area.

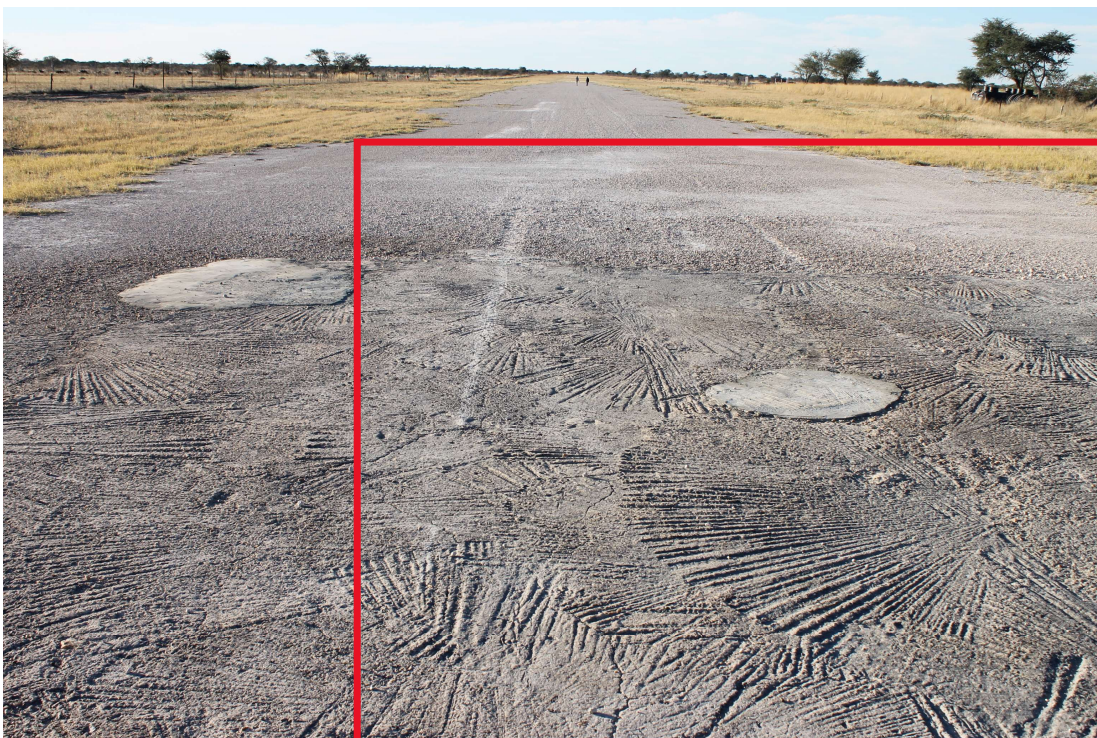
Figure 6b: View of the starboard (right side) main gear tracks.

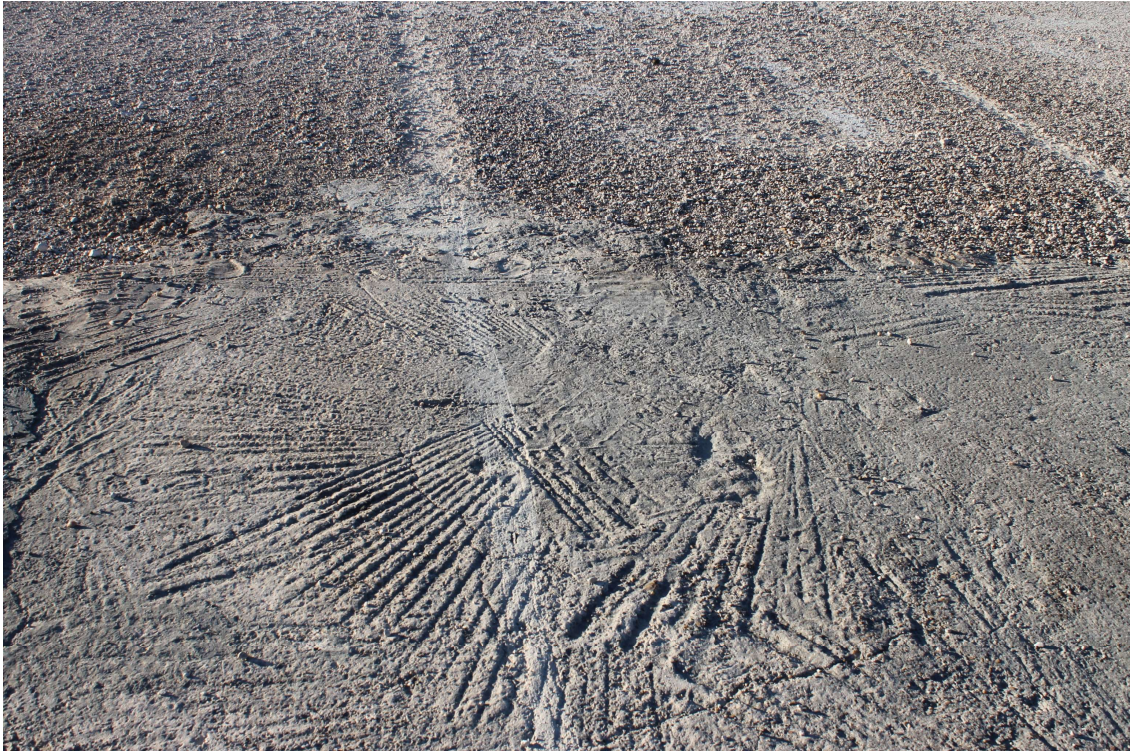
Figure 6c: Close up view of the starboard side main gear tracks

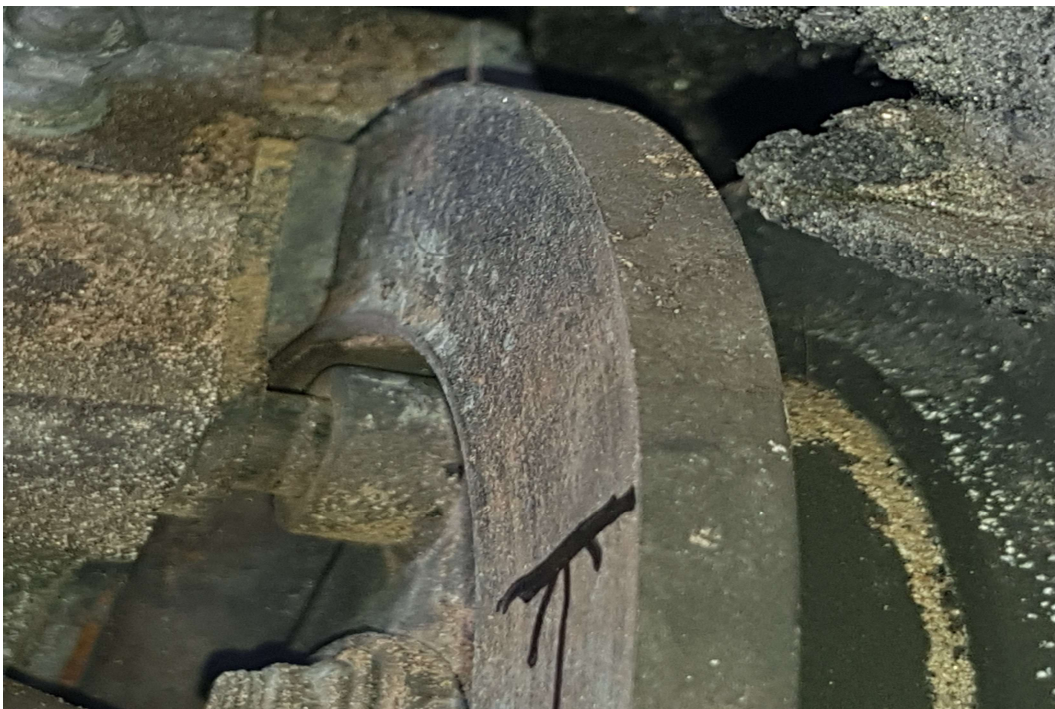
1.16.9 The port side main undercarriage wheel hub (disc) together with brake pads were found to be fully intact and in a brake position/mode. The brake pads were in full contact with the disc. **(Figure 7)**

Figure 7: Picture showing main gear brake pads engaged on the disc. (Port)

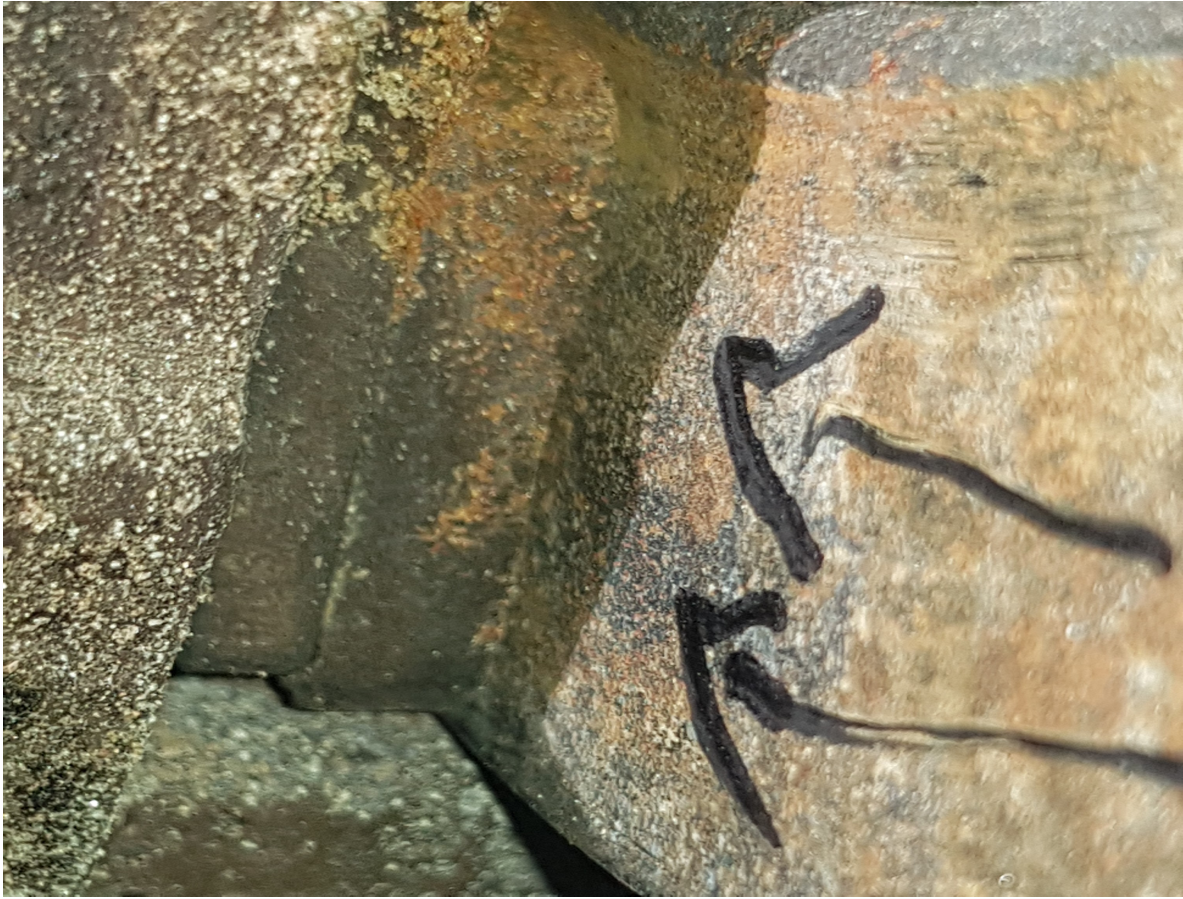
Figure 7a: Close view showing left main gear brakes pads engaged on the disc.
