AIRCRAFT ACCIDENT INVESTIGATION FINAL REPORT

REPORT ON AN ACCIDENT INVESTIGATION INVOLVING A GIPPSLAND
AEROSPACE (NOW MAHINDRA) GA – 8 AIRVAN REGISTERED A2 – MBE
THAT OCCURRED AT OAKDENE AIRFIELD ON THE 29TH JUNE 2023.

REFERENCE: MTPW/AIG/14/23

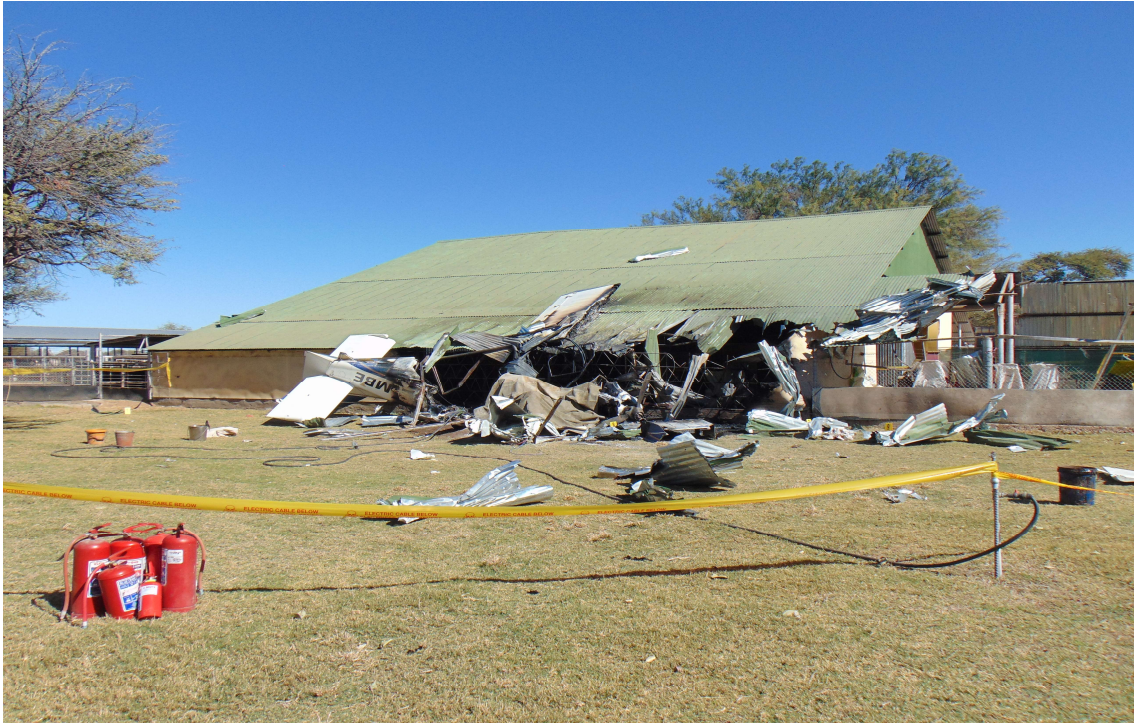
Figure 8: View of the final rest position of the wreckage and the destruction on the farm shed.
